CIRCULAR FOR P&I CLUBS

8 NOVEMBER 2021

GLOBALPANDI, S.A.
P&I CORRESPONDENTS

SCRAP METAL LOADING IN VENEZUELAN PORTS

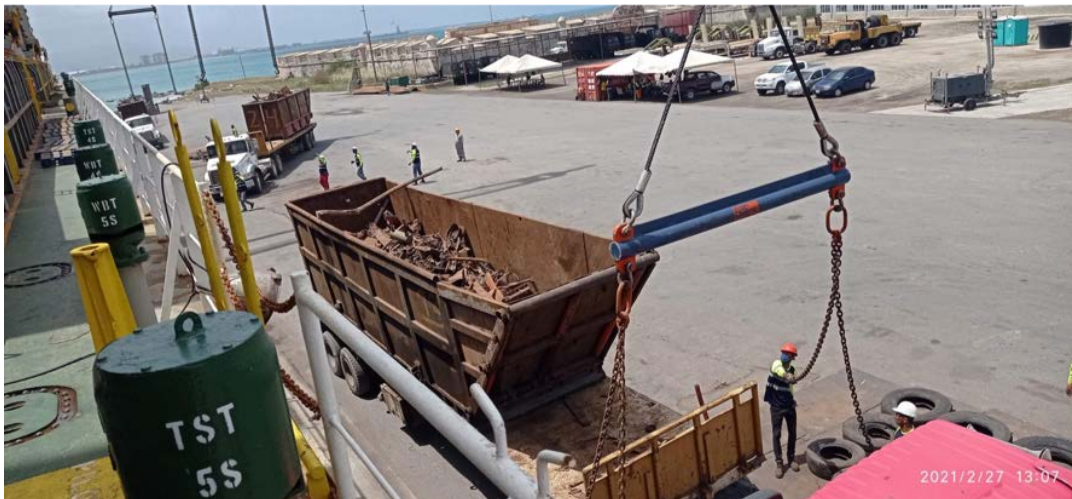
- Cargo quality: scrap metal cargo must be free from oil, lubricants, water this being a problem in the past.
- Physical damages to vessel's holds: specially on the initial stages of loading the open top containers which are tilted over have caused indent damages to vessel tank top and hold structures (side plating, frames, ladders, sounding and venting pipes) if done roughly.
- The open top containers – Gamelas – are of different size and given the irregular nature of the cargo and the lack of shore scale use, the weight of each Gamela is unknown and may exceed crane safe working load. Breaks of cargo

wires incident have occurred along with frequent limit switches stoppages of crane.

The “Gamelas” arriving alongside for discharging. Weights of each are unknown and cranes failures and stoppages are common.

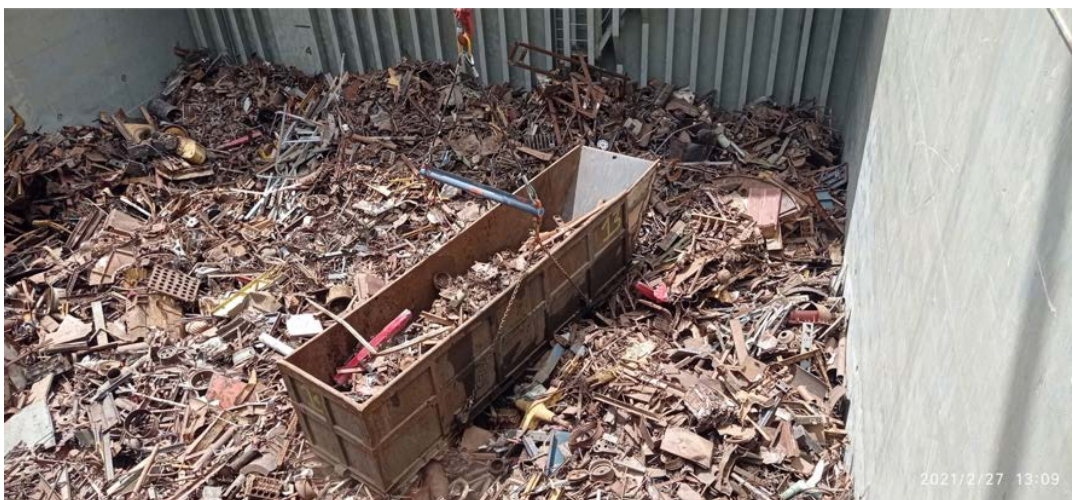
View of the loaded hold with the loaded “gamela” on top.

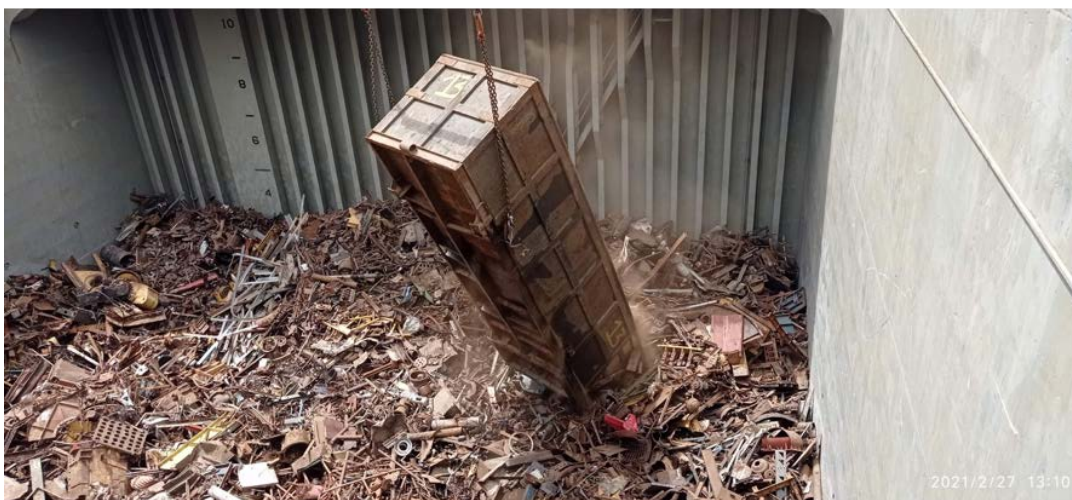
The “Gamela” is discharged in hold by tilting over – damages to holds structures are likely specially while commencing operations.

- Conducting an initial condition survey of holds and monitoring of operations for timely detect any vessel damages and protect member interests accordingly.
